Flooding in Sandy Creek Catchment, Mackay, following Tropical Cyclone Debbie

An independent assessment

Report to the Minister of Energy, Biofuels and Water Supply

June 2017

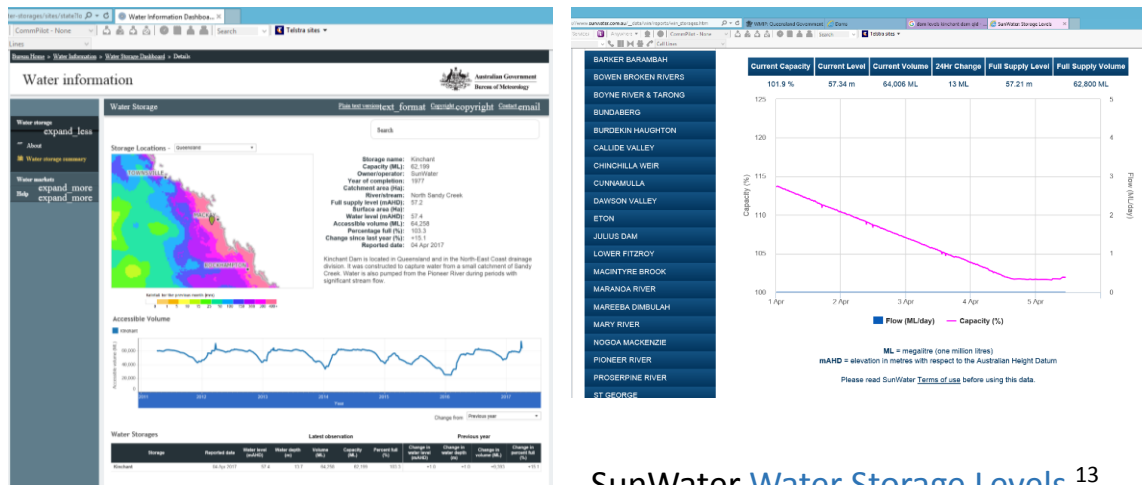
Bureau of Meteorology (BOM) collect all data from state government agencies and water supply entities, including [Kinchant Dam](#).¹²

SunWater [Water Storage Levels](#)¹³ provide access to available storage level reports and storage level information, reporting values recorded in a time series window (preceding 5 days only) and redirecting to BOM for historical information.

Storage level data for Kinchant Dam is also provided directly to the Department for Natural Resources and Mines (DNRM) and stored in the Queensland Government electronic data management system (Hydstra). A rating curve is used to convert dam height into discharge data (hourly-interpolated flow, m³/s).

Rating curves to calculate discharge data area are produced by government departments (DEWS, DSITI) as well as SunWater.

The [Kinchant Dam emergency action plan \(EAP\)](#)¹⁴ prepared by SunWater contains some information re outlet structures and their maximum rates of release.

Figure 3. Overview of data sourcing in relation to rainfall, dam height, dam flow and downstream flood volumes in relation to Kinchant Dam.

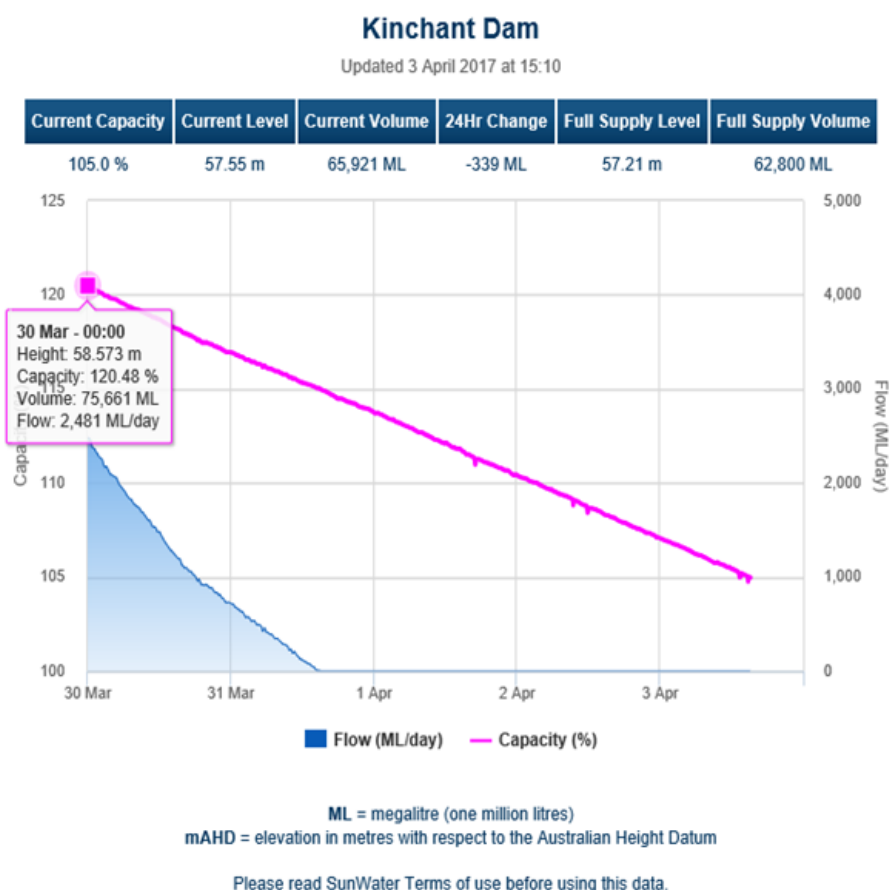
Figure 7. SunWater Screenshot provided by DEWS
 (<http://www.sunwater.com.au/_data/win/reports/win_storages.htm>)

DEWS provided a screenshot of Kinchant Dam storage levels (Figure 7), reported on SunWater's public website during the T.C. Debbie flood event.

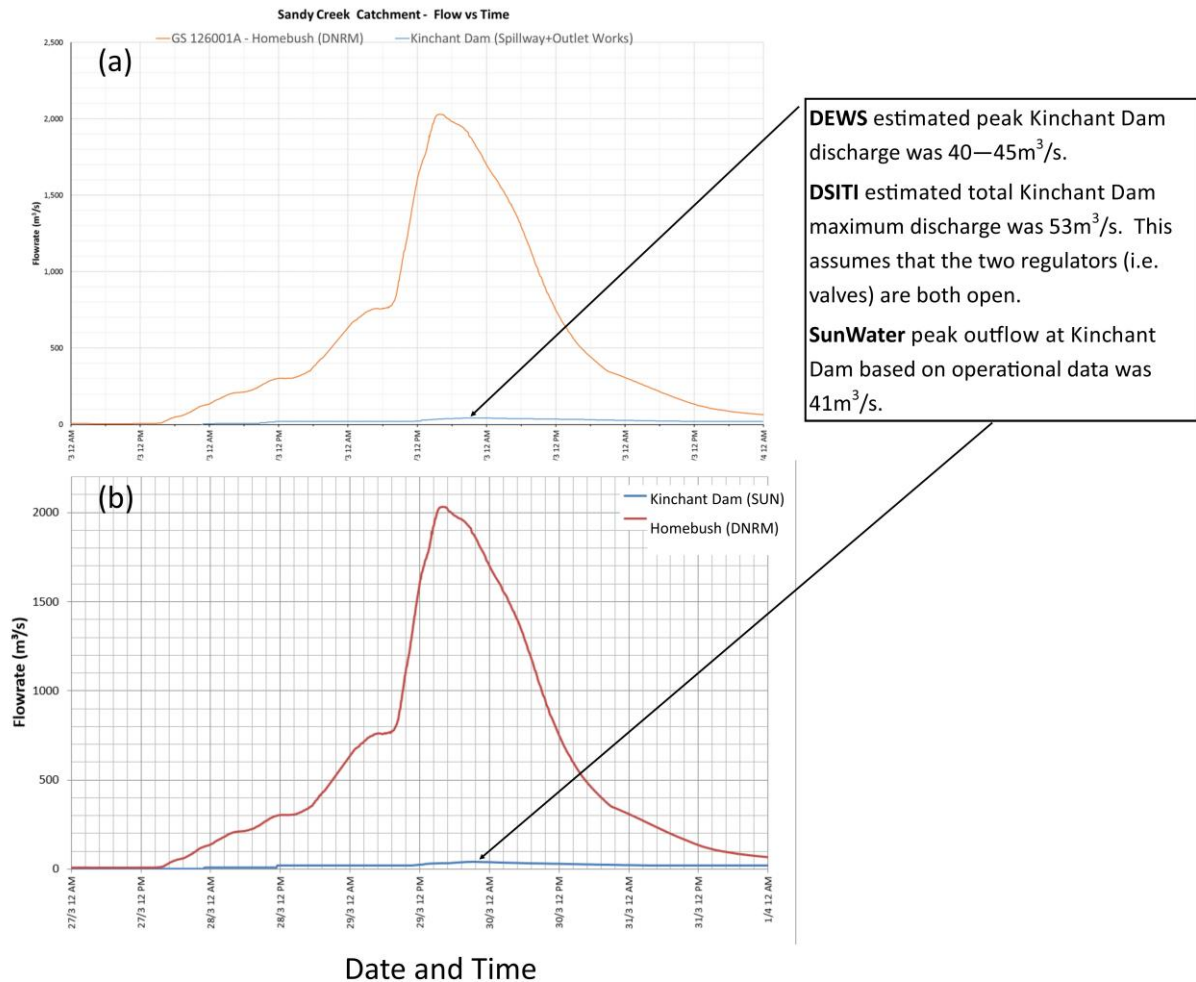
Figure 8. Hydrographs denoting flowrate (m³/s) during 27 March to 01 April 2017 for (a) Kinchant Dam discharge (blue line) and Homebush Gauging Station (yellow line), as provided by DEWS and (b) Kinchant Dam (blue line) and Homebush Gauging Station (red line) as provided by SunWater. Kinchant Dam discharge flow rates as estimated by DSITI and SunWater, are also shown (pop up box).

Flow Rate: To date, information from Queensland departments and SunWater regarding the Kinchant Dam discharge peak flow range between 40 to 53m³/s. Data provided by each source is overlaid in the figure provided by DEWS (Figure 8) which illustrates flow over time between Kinchant Dam discharge (spillway plus outlet works) and Homebush gauging station.

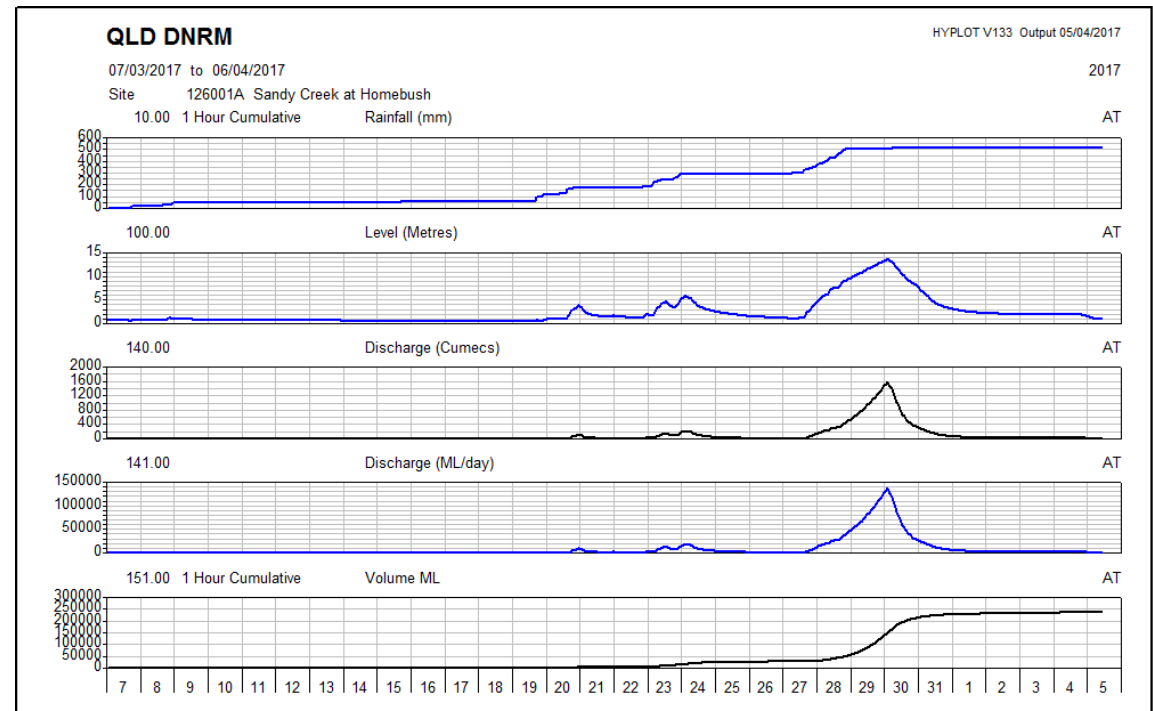
Figure 9. Sandy Creek @ Homebush Gauging Station, T.C Debbie records and location (marked with orange circle).^a

Further examples of flow rate, as expressed through the Water Monitoring Information Portal, are shown in Figures 9 and 10, below.

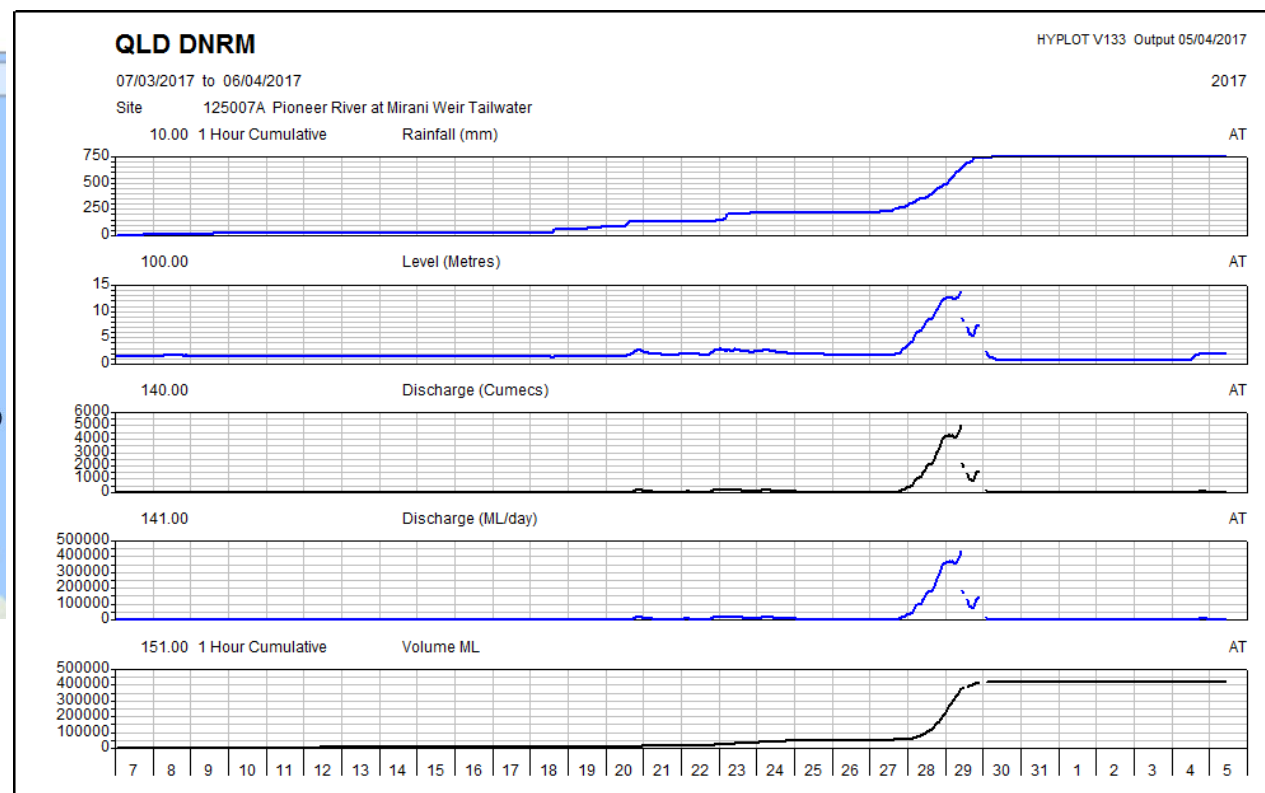
Figure 10. Pioneer River @ Mirani Weir Tailwater Gauging Station, T.C. Debbie records and location (marked with orange circle).^a

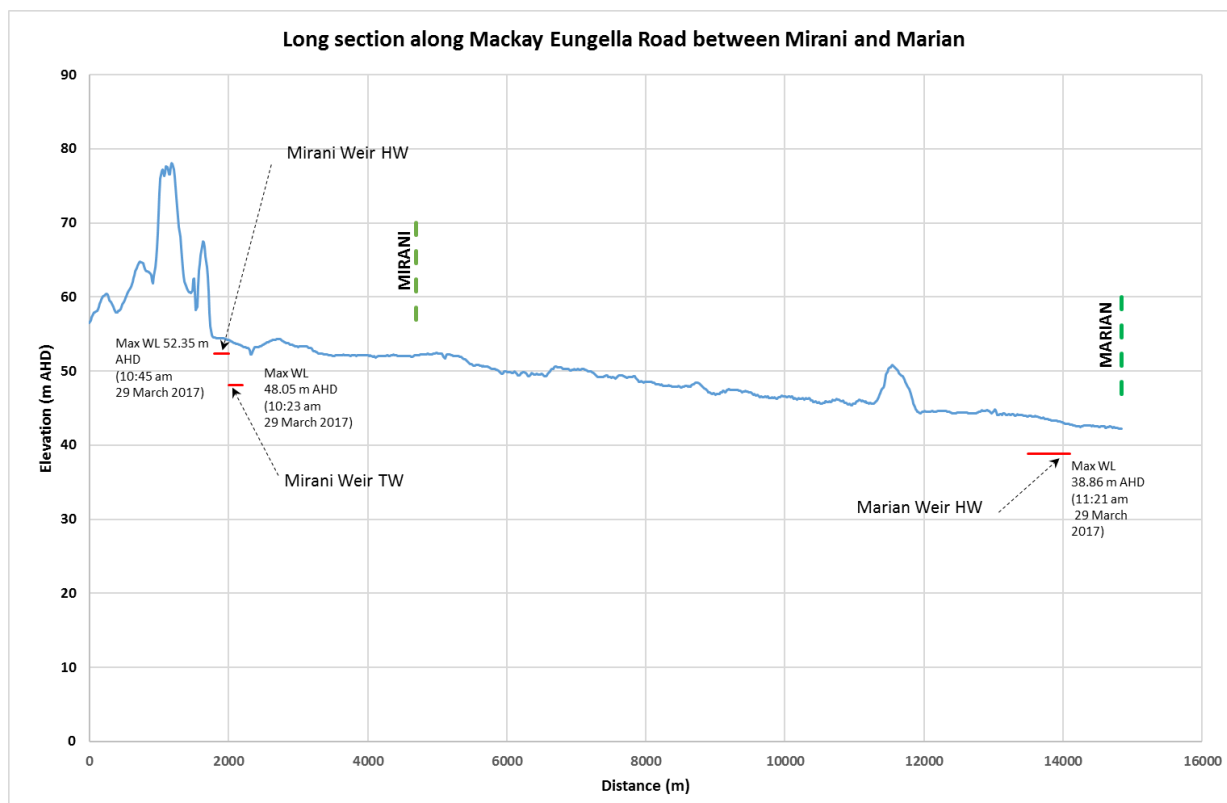
Figure 12. Long section along catchment divide between Pioneer River and Sandy Creek catchments, as assessed by DEWS. The alignment of the long section is as shown by the green line between Marian and Mirani in figure 4.

A preliminary desktop assessment was undertaken by DEWS of available ground level data together with the maximum recorded levels at Mirani and Marian weirs during the ex-T.C. Debbie flood. The assessment indicated that it was unlikely that the peak flood level in the Pioneer River resulted in outbreaks at this location, as shown in Figure 12.

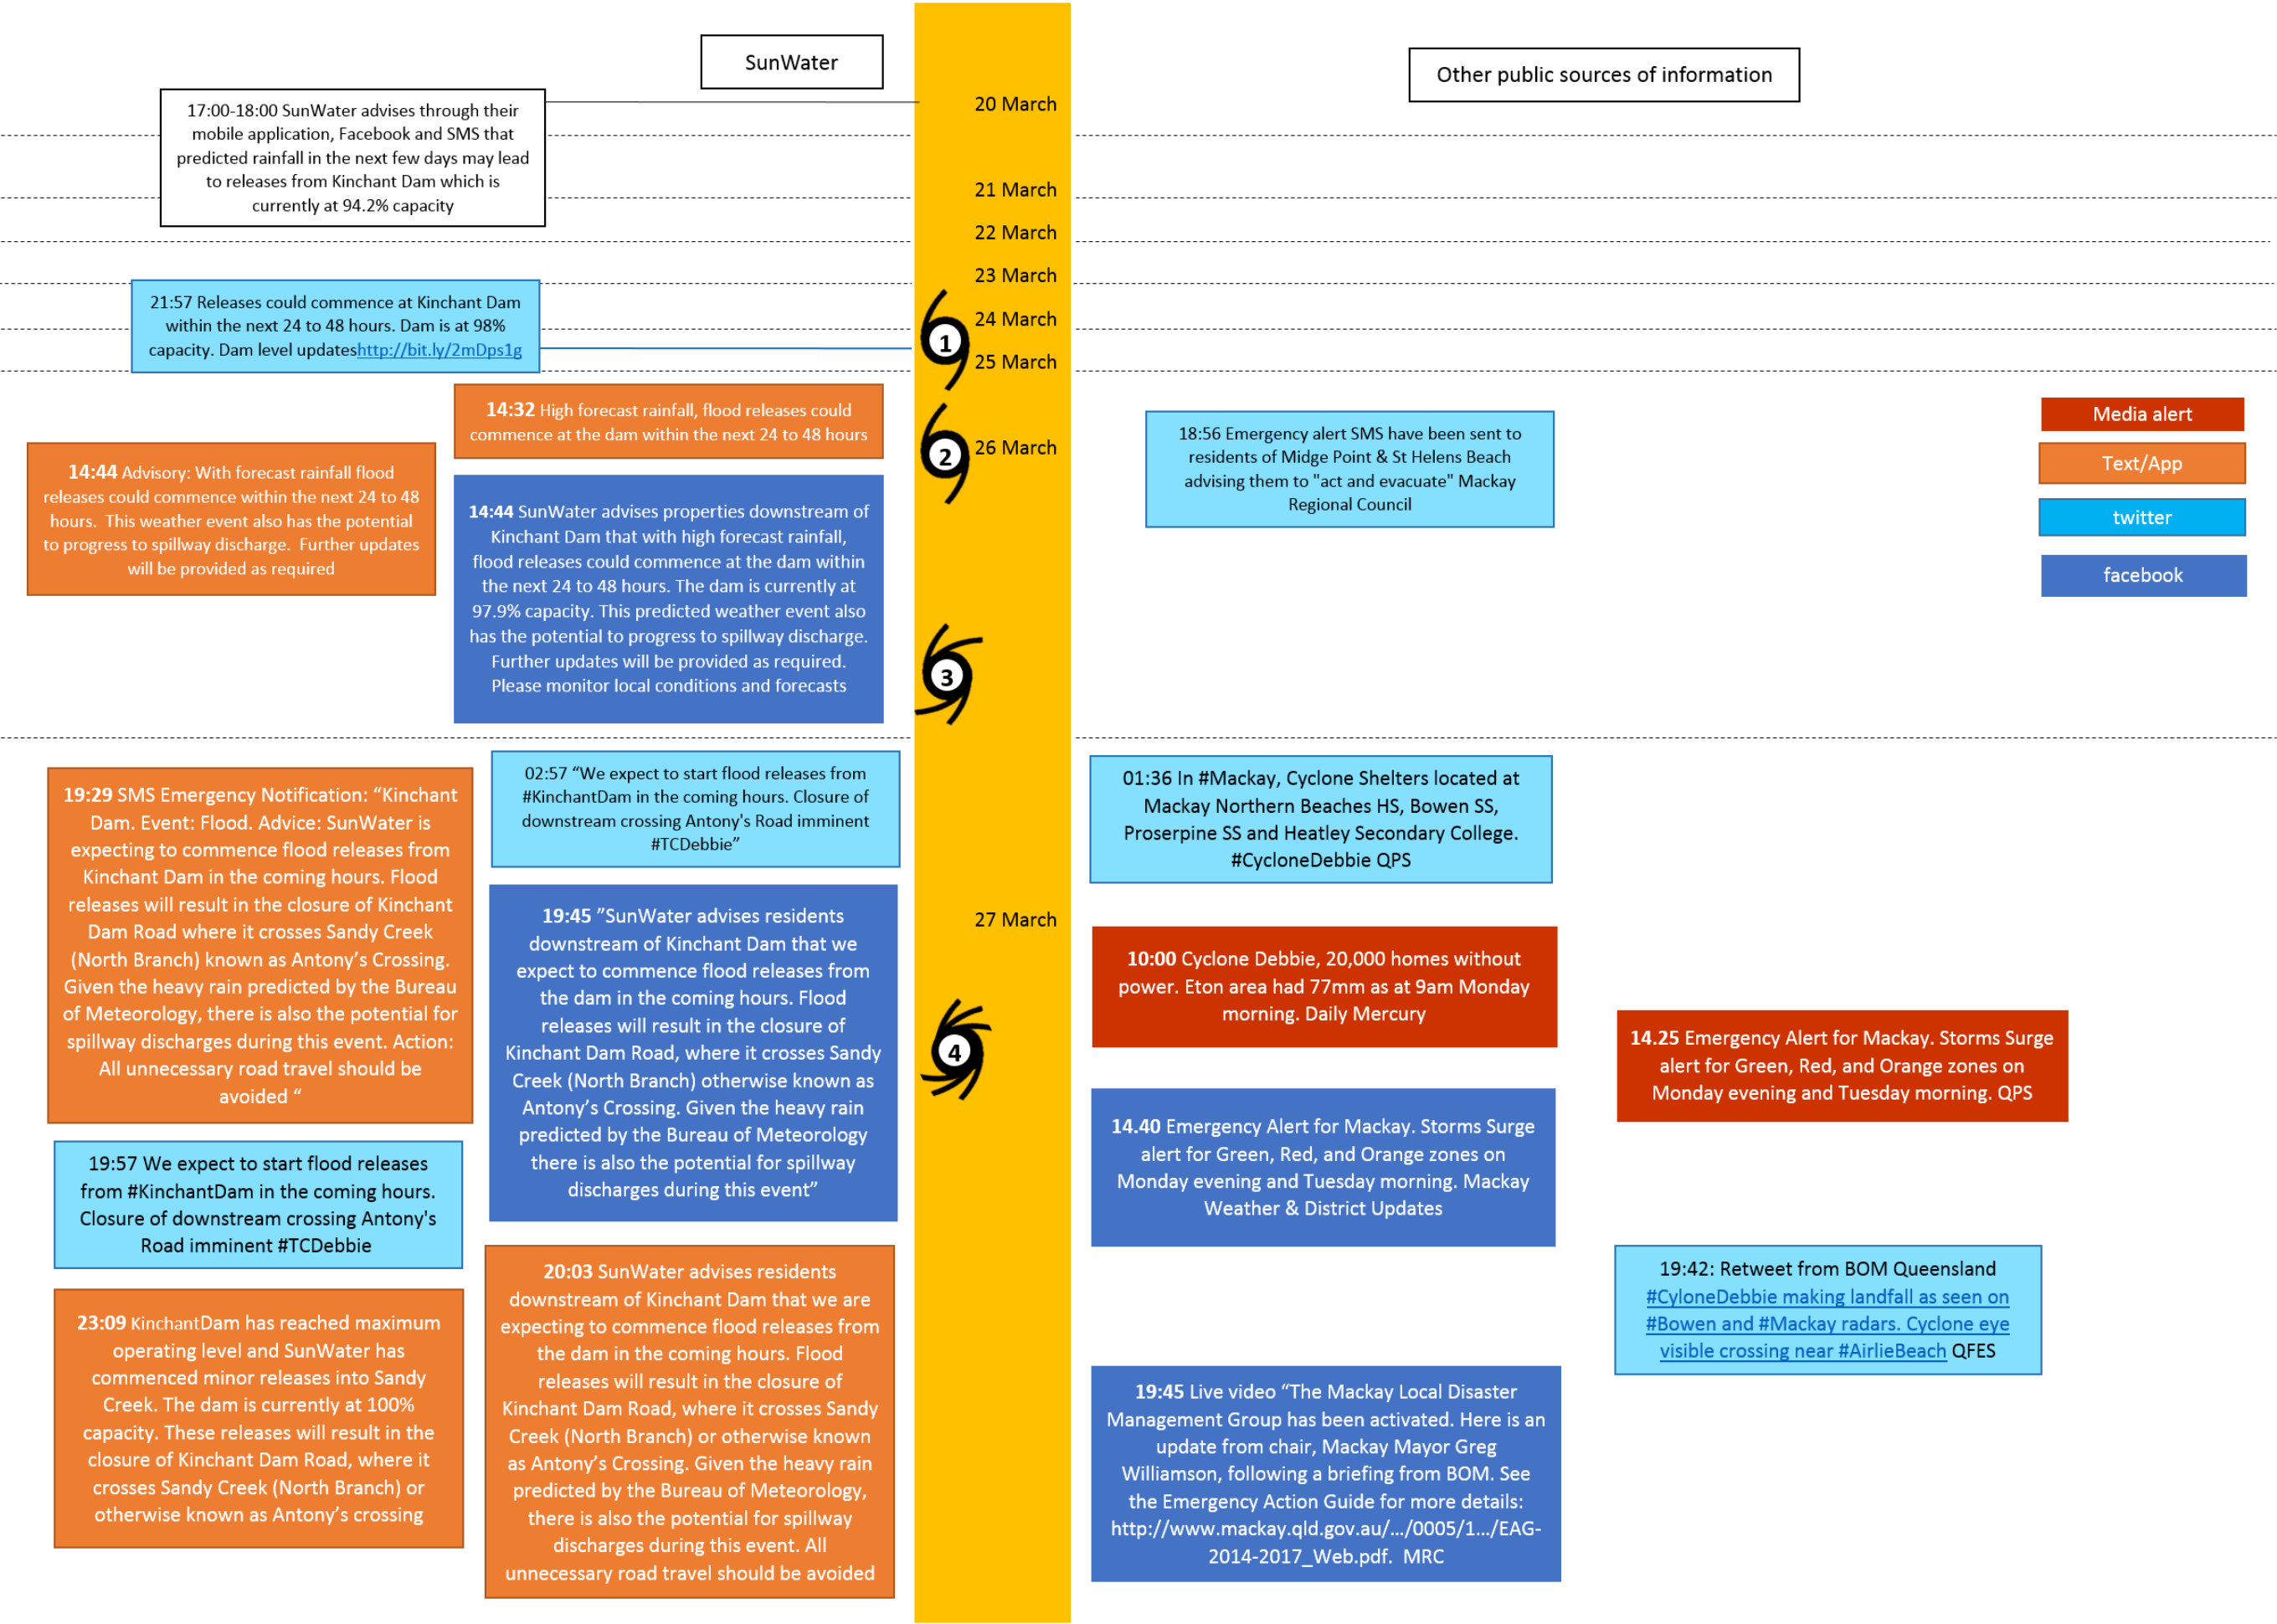
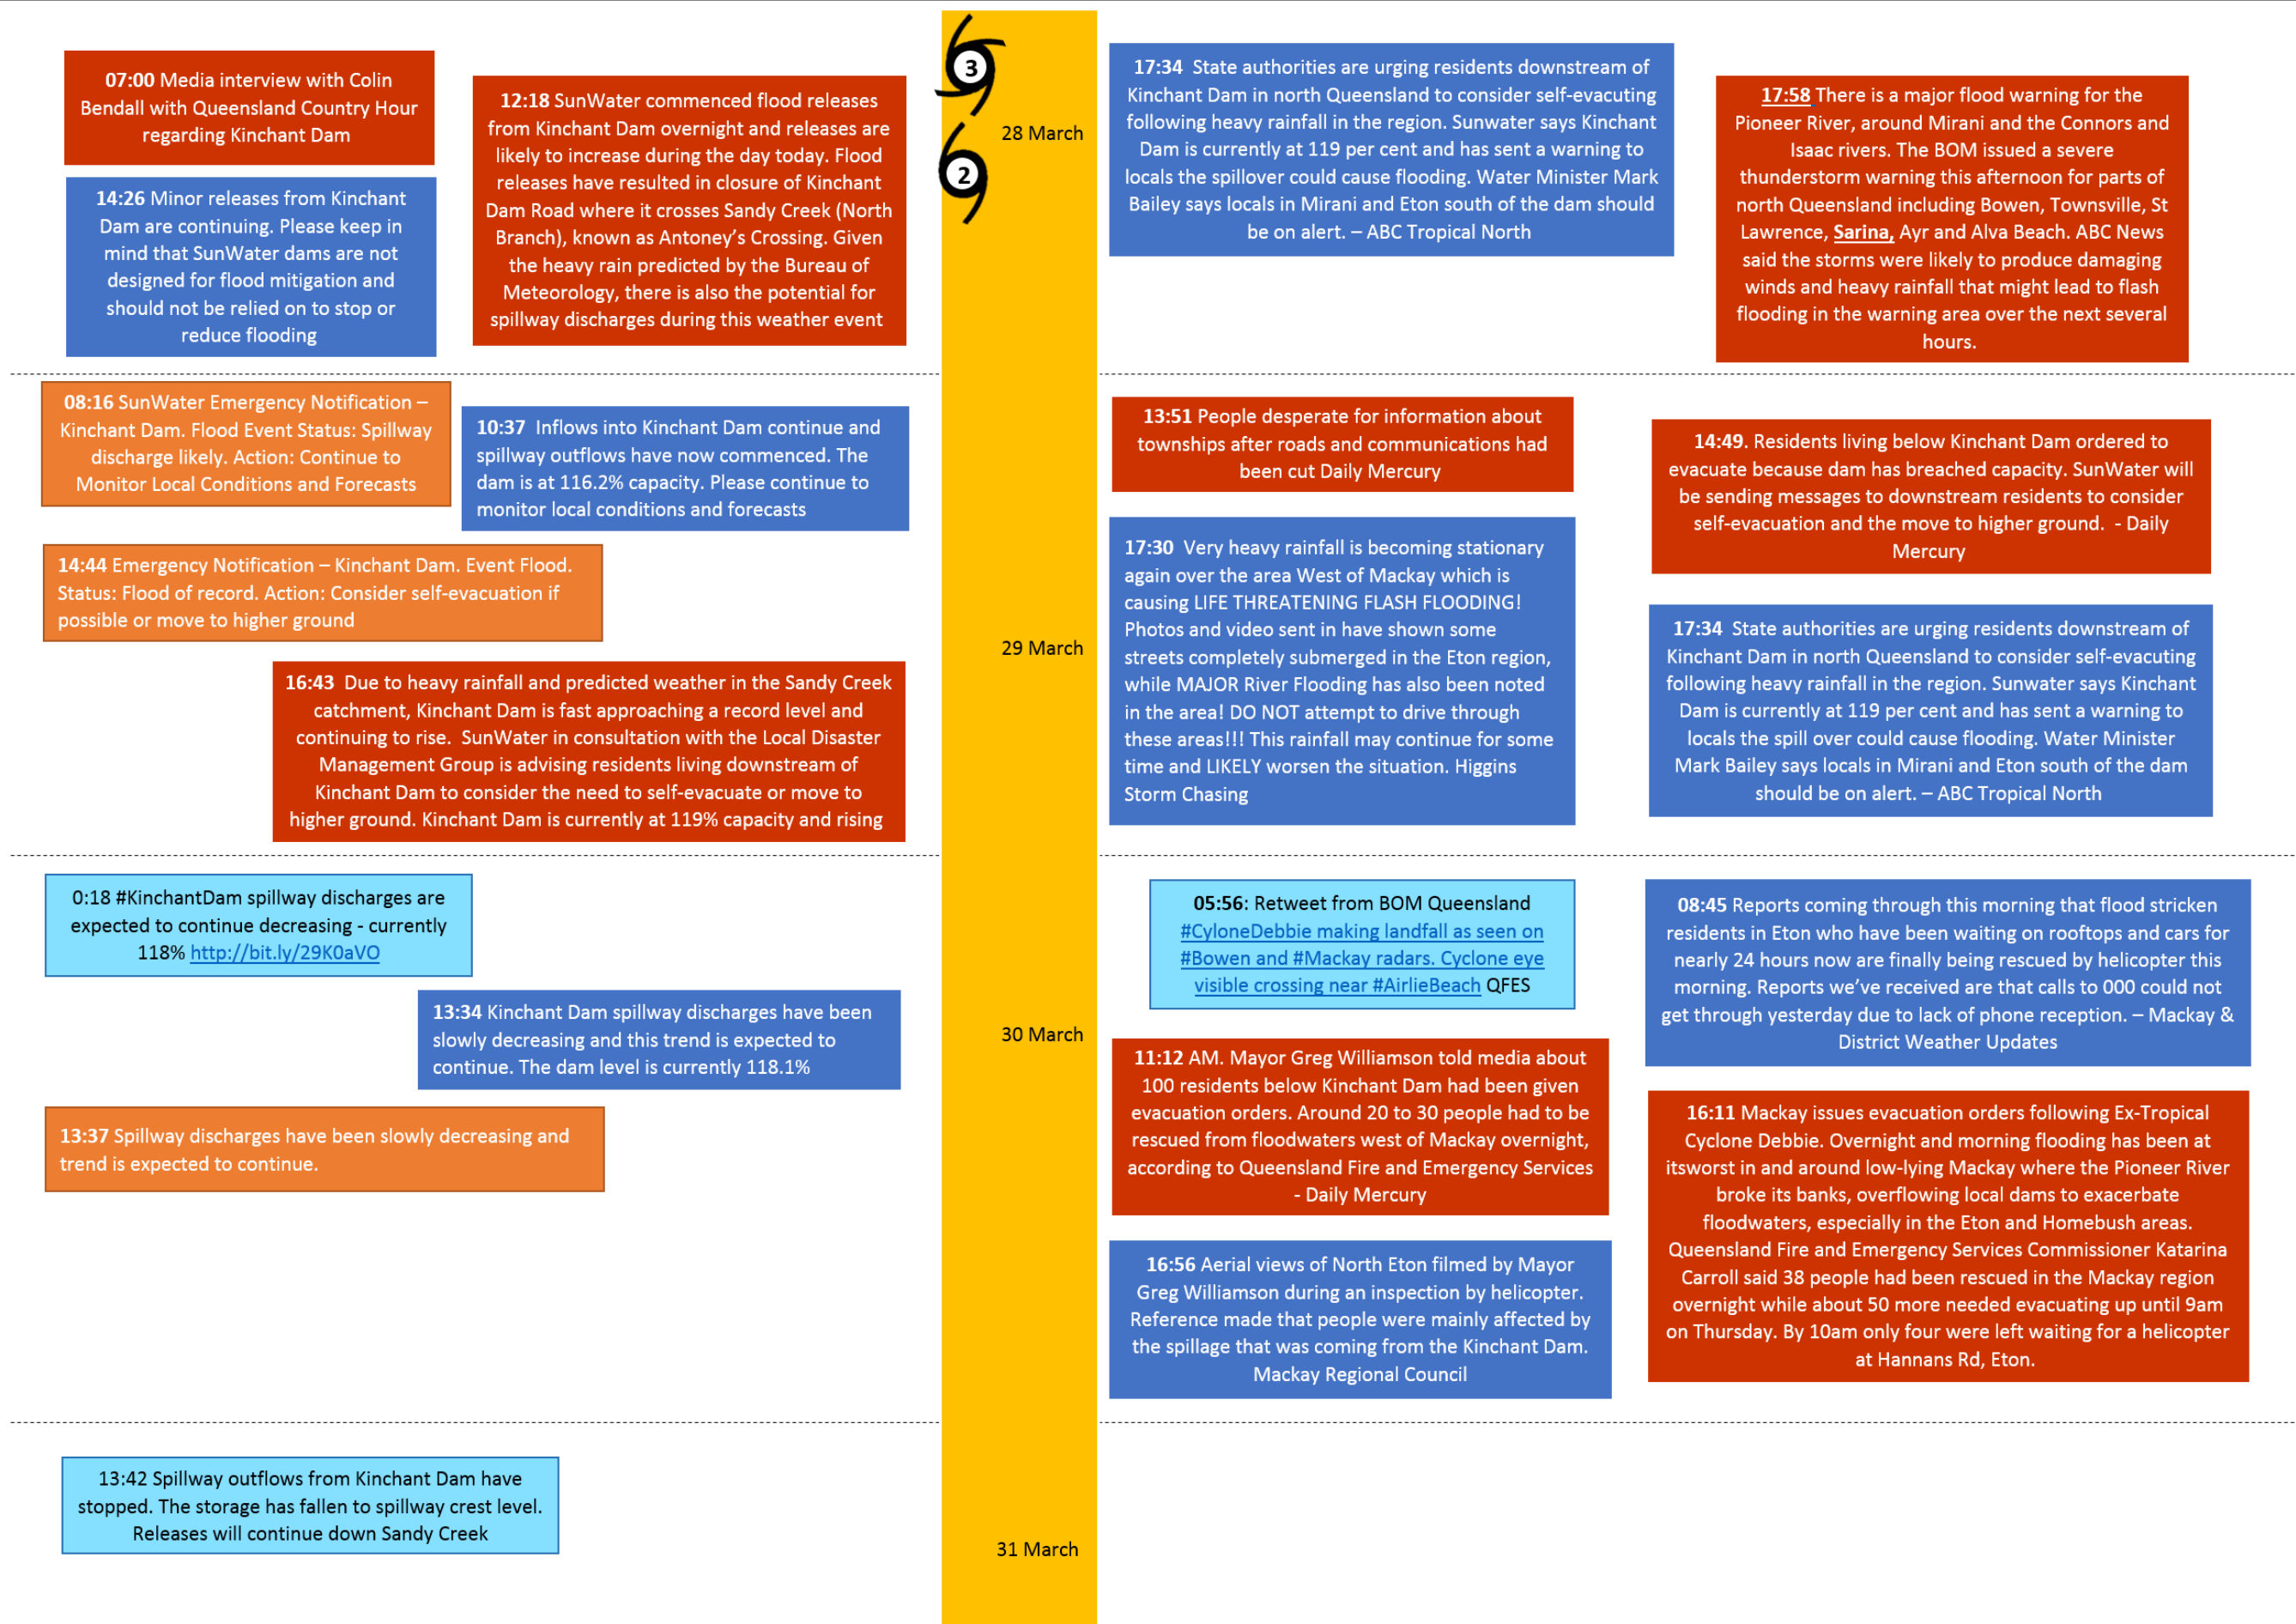
Figure 13. A summary of messaging and communications between 20 March and 30 March 2017

A summary of messaging and communications information as experienced by community members, populated against a timeline, is noted in Figure 13.
